RESERVOIRS

The chapter on Masonry Dams has been increased twofold by an attempt to make some mention of all the most notable dams of the world, and many that are very little known. Attention is particularly directed to Plates 1, 2, and 3, in which profiles are shown of all of the leading and better known masonry dams in existence, drawn to uniform scale for easy graphical comparison. No such complete collection of dam profiles has ever before appeared in print, assembled together on a common basis.

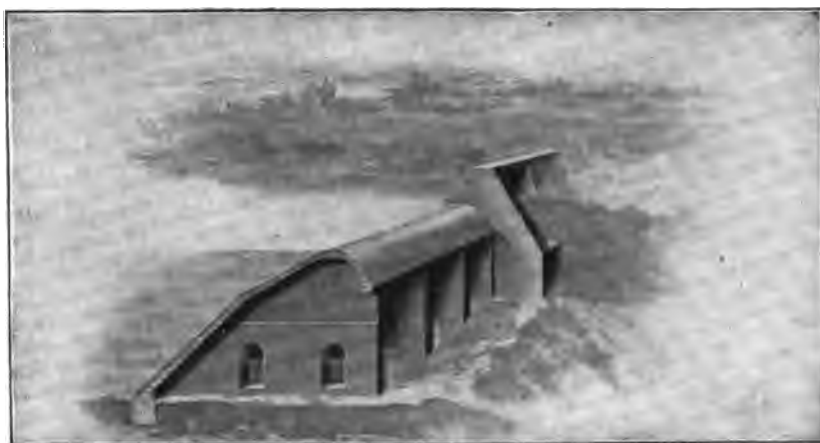
FIG. 307.

Fig. 307 shows in perspective and section the form adapted to low heads and hard foundations. It consists of a series of piers or buttresses, spaced 12 to 18 feet apart on centers, and covered with a deck of concrete, reinforced between the different bays as a beam, in which the tension members of steel are placed near to the under side, leaving from ten inches to several feet of concrete between the steel bars and the water. The thickness of the concrete sheet necessarily increased from top to bottom with the increase of head. But little reinforcement is used in the piers, except at

the edges and around the openings which are usually made through them, either for convenient passages or for the saving of material.

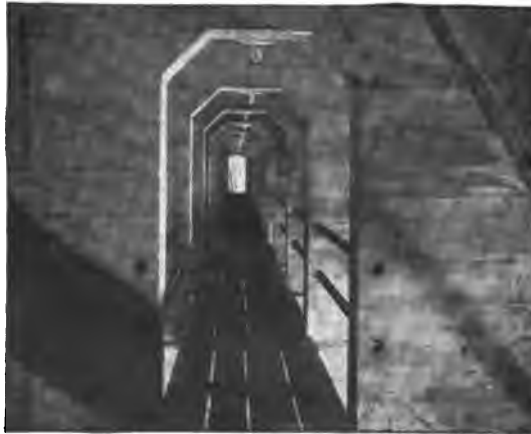
**FIG. 309.**

river to the other, as a substitute for a foot-bridge over the stream. Such a passage is illustrated in Fig. 309.

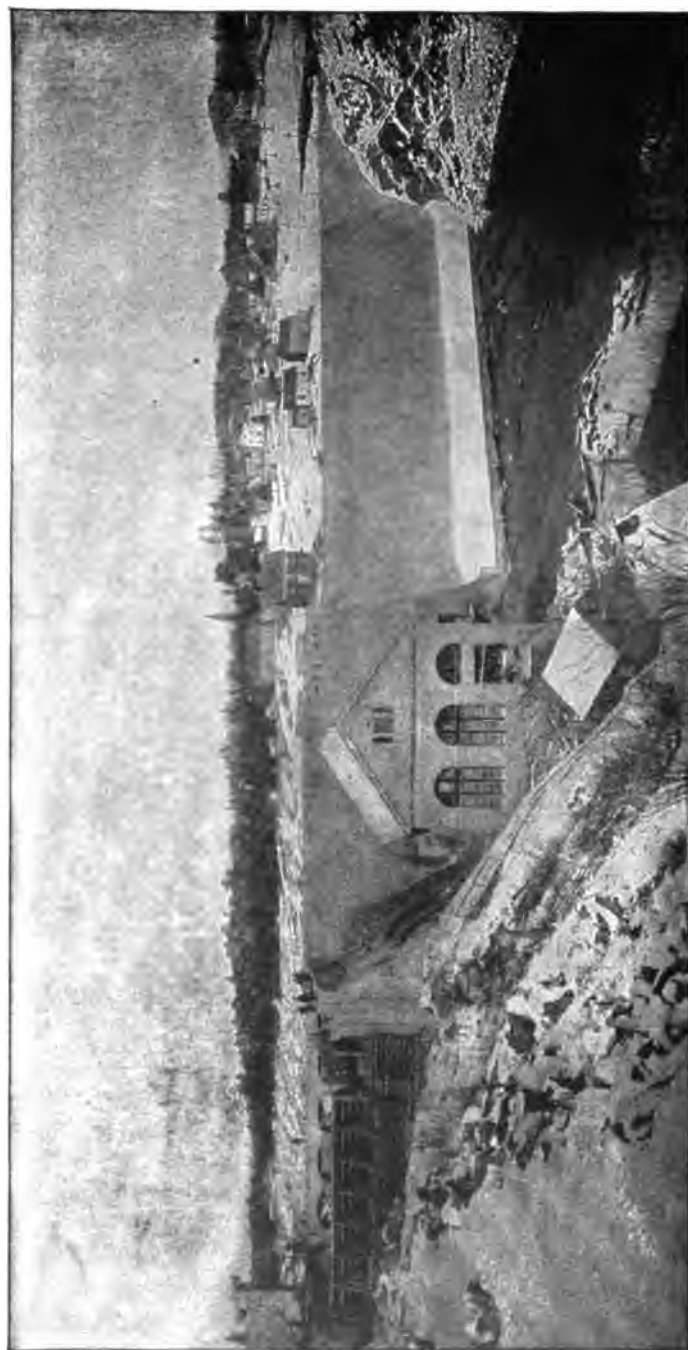
The high tension wires for the power house pass through portholes shown in the picture just underneath the top of the dam to the right of the power-house.

FIG. 312.—THE ELLSWORTH DAM AND POWER-HOUSE.

It is founded on granite, and the transverse profiles are very irregular, as shown in Fig. 305, which is a section through the rollway. The maximum height of the dam is 71.5 feet, in the bulkhead portion, back of the power-house. The rollway is 65 feet high. The total length of the dam is about 500 feet. The general plan, elevation and section of the structure are shown in Fig. 306. The space underneath the bulkhead and immediately in the rear of the power-house is utilized as a transformer-house, store-house, machine-shop, etc., while the power-house is approached from the town on the opposite side of the river by a tunnel beneath the low part of the crest and a passage at different levels entirely through the body of the dam. The structure is shown in Figs. 312 and 316.

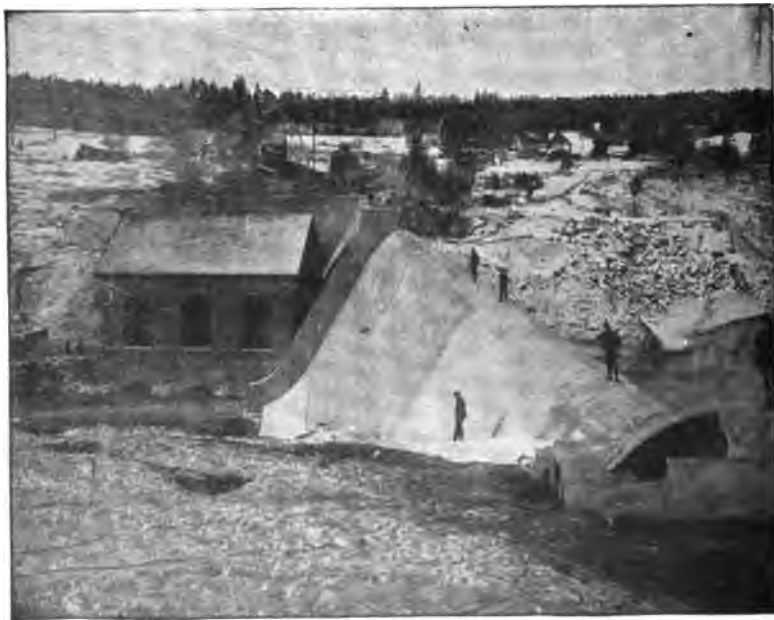
FIG. 316.—ELLSWORTH DAM, MAINE.

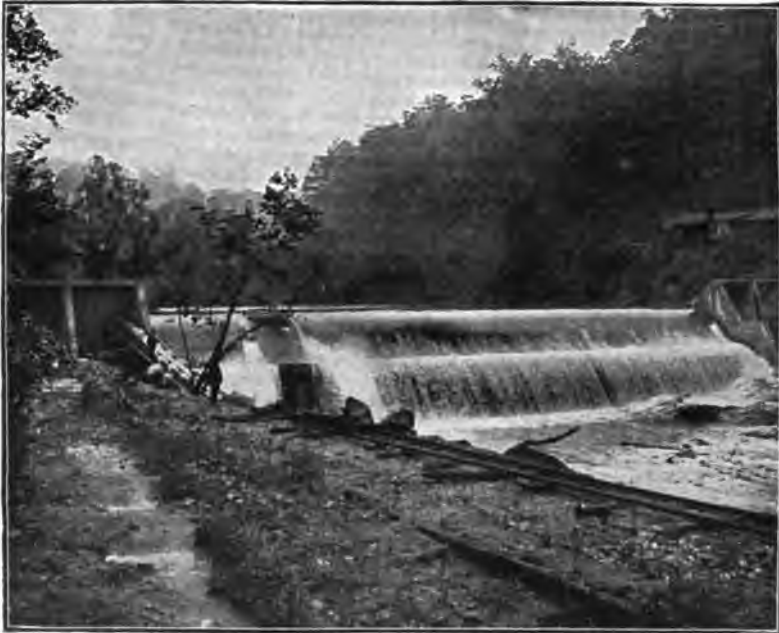
FIG. 317.—PATAPSCO DAM, ILCHESTER, MARYLAND.

became necessary to utilize the room in the hollow interior for the power-house, in which three units of 500 H. P. were snugly installed. The dam is of the half-apron type, affording ample daylight on the downstream side. The cubic contents of this dam are but 2200 cubic yards. A general view is shown on Fig. 317.

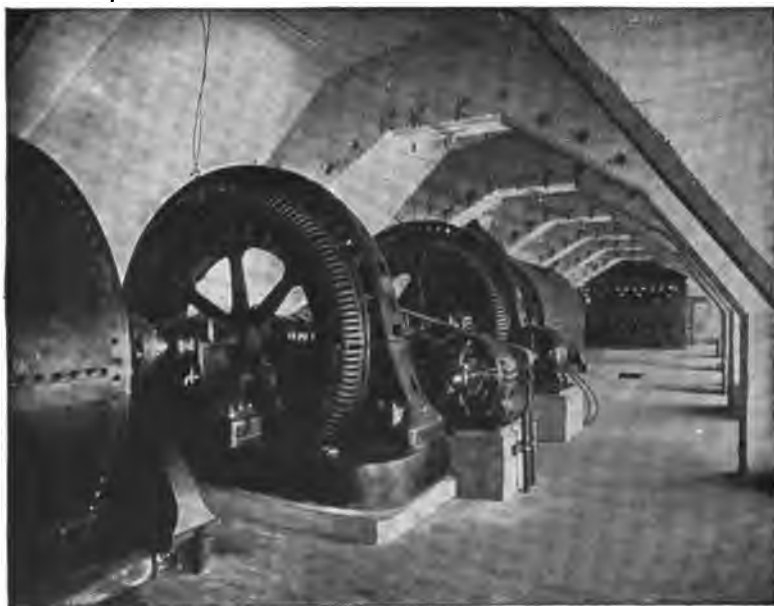
FIG 319.—INTERIOR OF PATAPSCO SUBMERGED POWER-HOUSE.

Fig. 318 is a cross-section of the dam with its enclosed power-house, and Fig. 319 shows an interior view of the power house after completion.

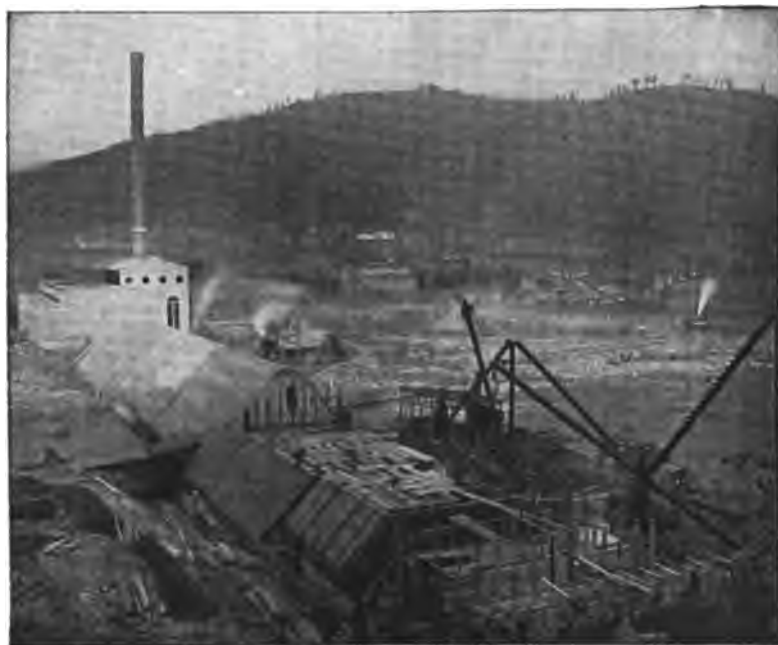
FIG. 321.—JUNIATA DAM, AND POWER-HOUSE PARTIALLY COMPLETED.

Fig. 321 gives a clear view of the work at an advanced stage, with the river flowing through openings beyond the cofferdam, and Fig. 323 shows the completed dam and power-house. The dam in the rollway section is 28 feet high and 460 feet long. It contains 6400 cubic yards of concrete, including abutments and bulkheads.

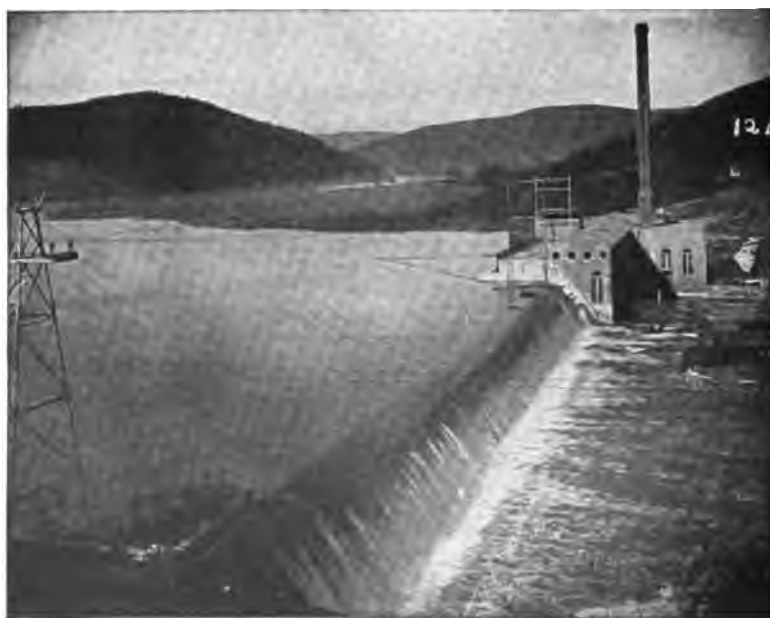
FIG. 323.—VIEW OF COMPLETED JUNIATA DAM.

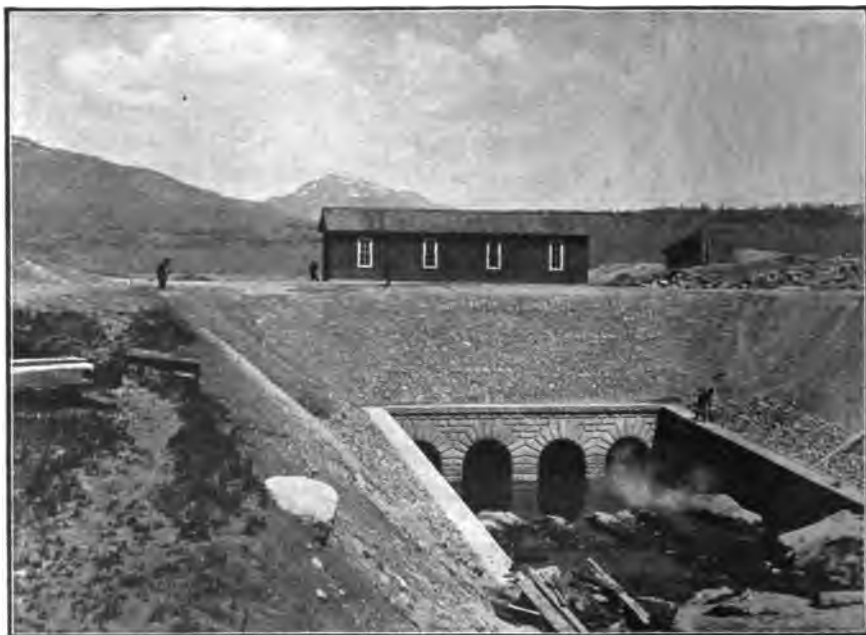
FIG. 331.—TWIN LAKES, COLORADO, MASONRY DAM OVER OUTLET, WITH EARTH BACKING, GATE-HOUSE, AND OUTLET CULVERTS.

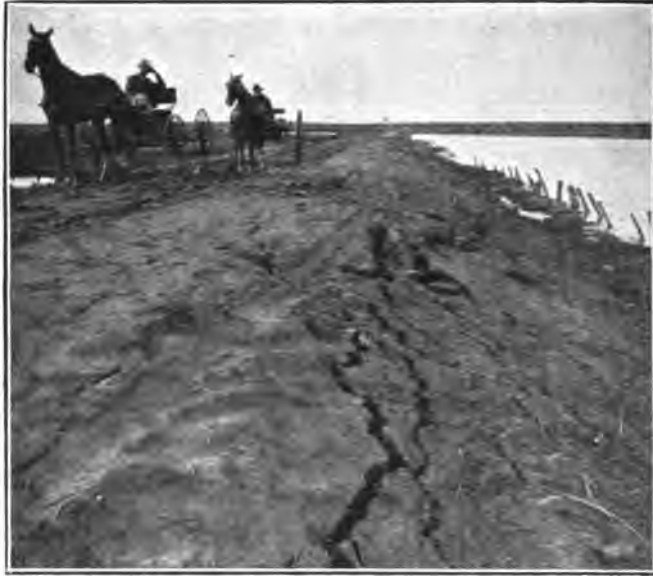
The Douglas Lake Reservoir, Colorado.—An earth dam across a natural depression on Dry Creek, five miles northwest of Fort Collins, Col., was built in 1902, an illustration of which is shown in Fig. 333.

The great cracks in the dam are the conspicuous feature of the picture, and are evidence of the lack of proper care and supervision in important works of this character. The dam contains about 150,000 cubic yards of earth, and forms a reservoir of 10,600 acre-feet capacity, sufficient to create great havoc in the country below it if it were suddenly released. The reservoir is filled by a ditch from the North Poudre river.

FIG. 333.—DOUGLAS LAKE DAM, COLORADO, SHOWING DANGEROUS SETTLEMENT CRACKS, DUE TO IMPROPER METHOD OF CONSTRUCTION.

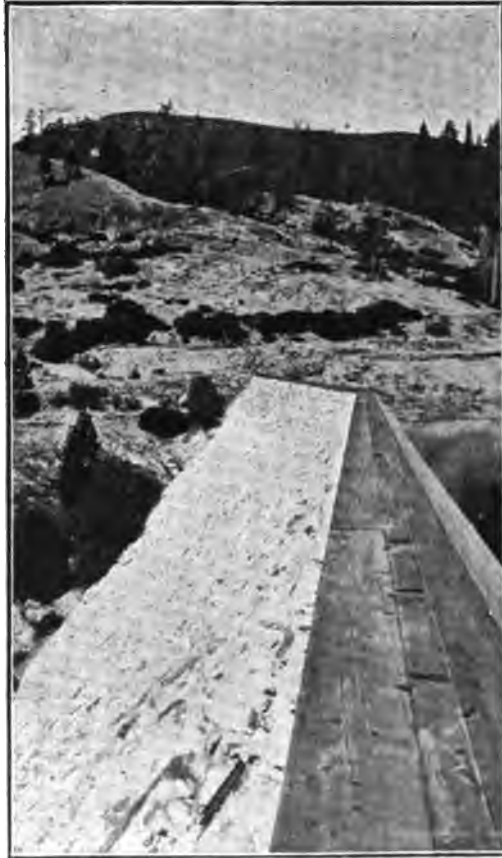
FIG. 337.—NEAR VIEW OF CREST OF BOWMAN LAKE DAM, SHOWING ANGLE IN DAM.

The Bowman Rock-fill Dam.—Renewed interest is being taken in the old rock-fill dams of the Sierra Nevada Mountains, in Northern California, built originally to store water for hydraulic mining, because they are becoming valuable for the double uses of generating power and affording domestic and irrigation supply to the valley below. The Bowman dam, described on page 65, and outlined by cross-sections, Fig. 44, is more clearly illustrated in its situation and construction by Figs. 336, 337, 338, 339, and 340.

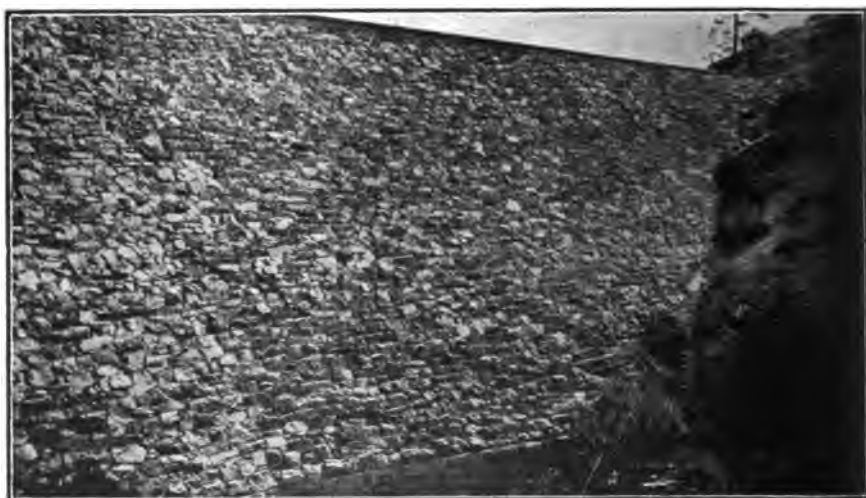
FIG. 338.—DOWN-STREAM FACE OF BOWMAN LAKE DAM, CALIFORNIA, ILLUSTRATING THE QUALITY OF THE DRY MASONRY.

17,000 cubic yards of stone filling, 33,000 lineal feet of heavy timber, and 63,000 feet, B. M., of three-inch plank. It was actually designed to carry flood water over its crest to a depth of 3 feet for a length of 300 feet in emergency. The main spill-way, however, is an entirely separate structure, as described later. Before this work was finally completed it was destroyed by fire, October 12, 1871, and again damaged, or practically destroyed, by flood at the end of the same year. In 1872 it was rebuilt to a height of 65 feet, after the same plan as before, with flash-boards on the crest, raising its height to a total of 72 feet. The final increase in height was made, and the dam completed as it now stands, December 10, 1876. Its height has always been called 100 feet in round numbers, but its actual measure is 96 feet at the highest point.

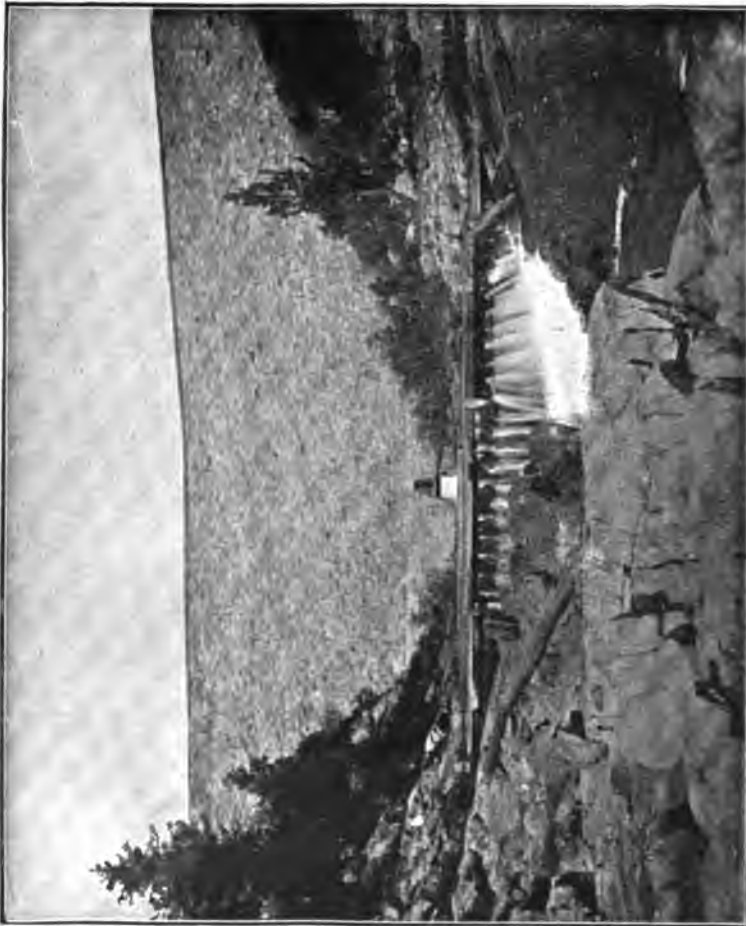
FIG. 339.—FRONT VIEW OF BOWMAN LAKE DAM, FROM BELOW MEASURING WEIR.

The present dam contains a great deal of the old timber structure at the bottom unburned in the fire. The upper part of the timber facing differs from the old design in that the inclined posts on which the plank skin is spiked are not parts of timber bents, but are merely embedded into the face of the rock-fill and anchored back into the rock, so that

the first layer of plank is placed horizontally and not vertically as before. At the base the 3-inch plank are in three layers; at the top is but one layer. The plank facing of the lower half of the dam, laid in 1876, is still serviceable after thirty-two years of wear. The upper half of the planking has been replaced once. Since the dam was built, in 1876, there has been a sag in its center amounting to about 12 inches, due to the decay of the timber in the cribs and the settlement of the rock.

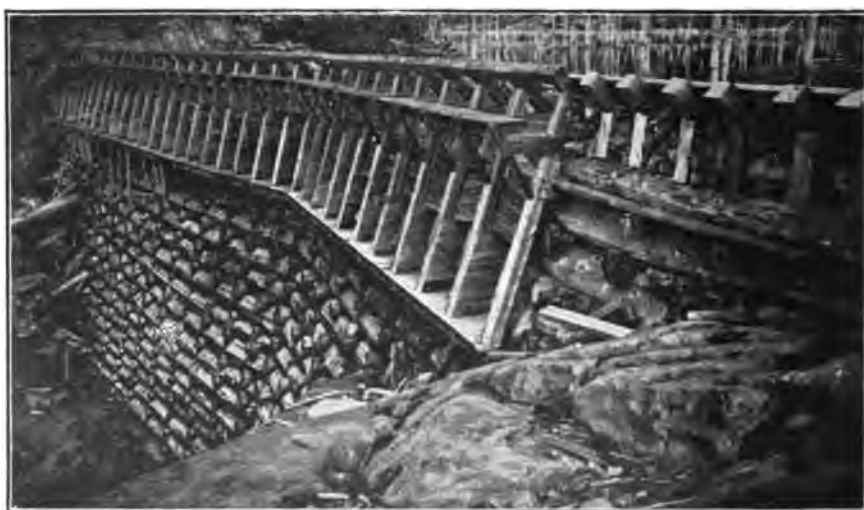
FIG. 340.—TIMBER CRIB SPILLWAY OF BOWMAN LAKE DAM. THIS STRUCTURE IS 52 FEET HIGH.

Spillway.—While the main dam was intended to act as an emergency overflow, or spillway, the principal spillway is a separate structure (Fig. 340), 52 feet high, built of round logs fastened together by 1-inch drift bolts, forming a crib, filled with small stone. This structure is also covered with a skin of 3-inch plank on the water side, and has a slight angle pointing up stream. The crest is 12 feet lower than the crest of the main dam. It is arranged with A-frame bents so that flash-boards may be added to raise the water 8 feet. There are thirty-one openings

between bents, each 4 feet wide. During the flood season the flash-boards are removed, but when all danger of floods is supposed to be past these wasteways are closed with 2-inch loose planks. This structure, built in 1876, has had little or no repair since that date, and has sagged very perceptibly. The ends of the main timbers are torn from the walls of the canyon, and the header logs have rotted to a soft pulp at their extremities, where exposed to the weather. The water passing through or over this spillway leaps clear of the log face on the downstream side, otherwise it would not have lasted as long as it has.

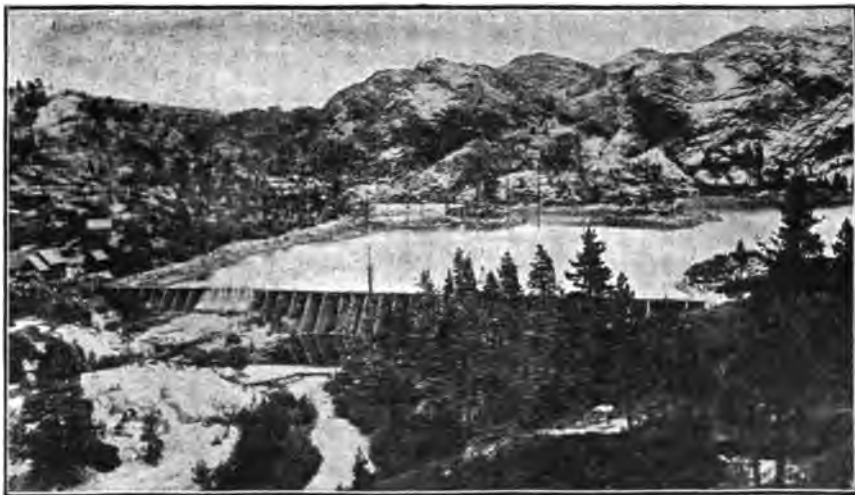
FIG. 341.—THE FAUCHERIE DAM, CALIFORNIA. A GENERAL VIEW OF DAM AND RESERVOIR.

The Faucherie Dam.—The Faucherie Dam is a good example of a timber-frame dam, with all rock-filling omitted. Its original height was 35 feet, but after its destruction in the early winter of 1875, it was

rebuilt with a reduced maximum height of 21 feet (see Figs. 341 and 342). The frame supporting the inclined face is triangular in form, leaning

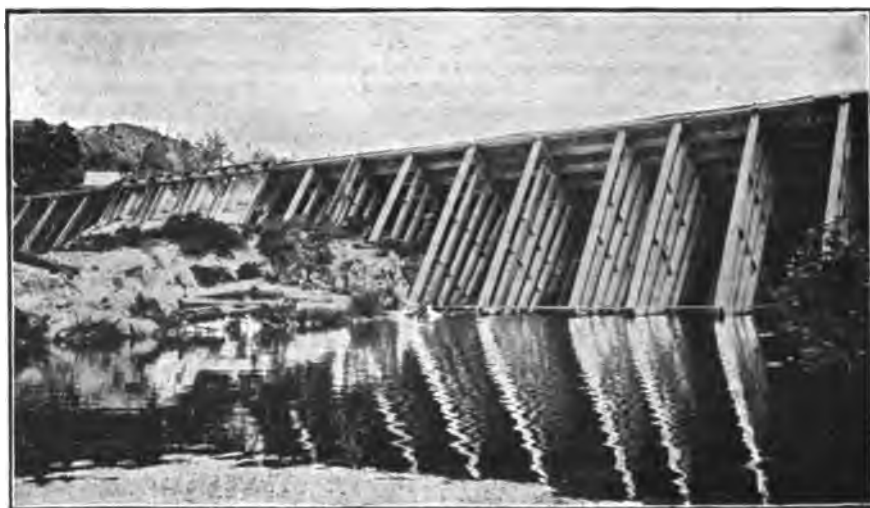
FIG. 342.—THE TIMBER WORK OF THE FAUCHERIE DAM AS SEEN FROM BELOW.

down stream at an angle of 55° . The struts supporting the frame have angles varying from 45° to 60° from the horizontal, the latter being the inclination of the longer outer posts.

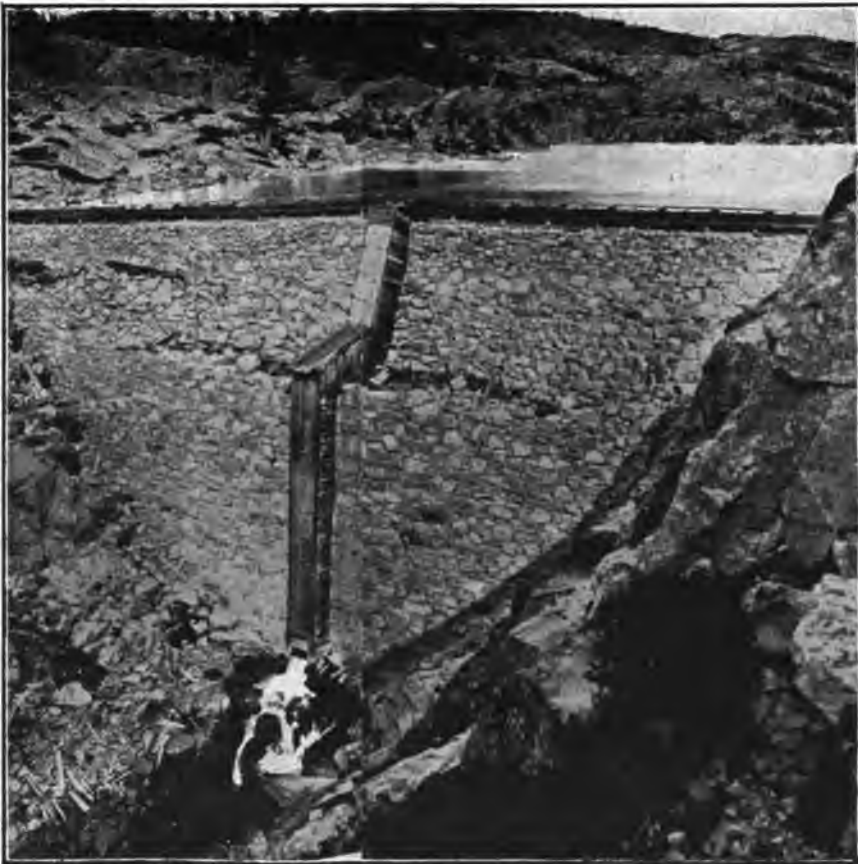
FIG. 343.—THE EUREKA LAKE ROCK-FILL DAM, CALIFORNIA, SHOWING COVERED MAN-
WAY TO REACH GATES FROM CREST IN WINTER.

The offset shown in the photographs (Figs. 343 and 344) was the result of an enforced economy during construction when money became scarce. The dam is built entirely of rock (without timber cribs), rather loosely placed, and with the larger stones in the down-stream face laid up in the form of a dry wall. The up-stream face is made water-tight with two layers of a 3-inch pine planking, laid with broken joints, spiked to inclined posts sunk flush with the stone work, which is also laid up with care as a dry wall, to receive the pressure of the water transmitted through the planks. On the crest is a timber structure about 6 feet high, made by extending the inclined posts and timber facing above the stonework.

The water is drawn out through an arched sluiceway under the center of the dam, the gates of which are only accessible in winter through the box-like structure, or manway, shown in the photographs, which protects the ladder resting on the face of the dam from the deep snow. The gates are situated near the water face of the dam, at the end of the arched sluiceway.

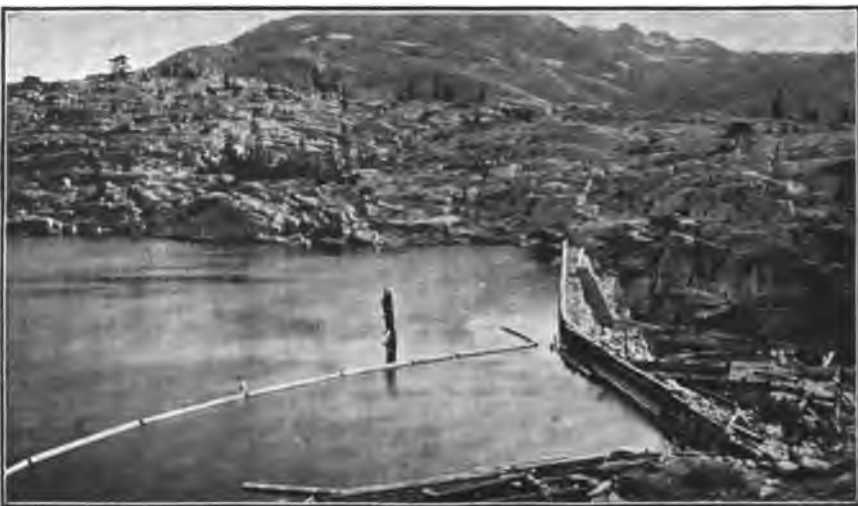
FIG. 344.—SHOWING THE CREST OF THE EUREKA LAKE ROCK-FILL DAM, AND A PORTION
OF THE LAKE.

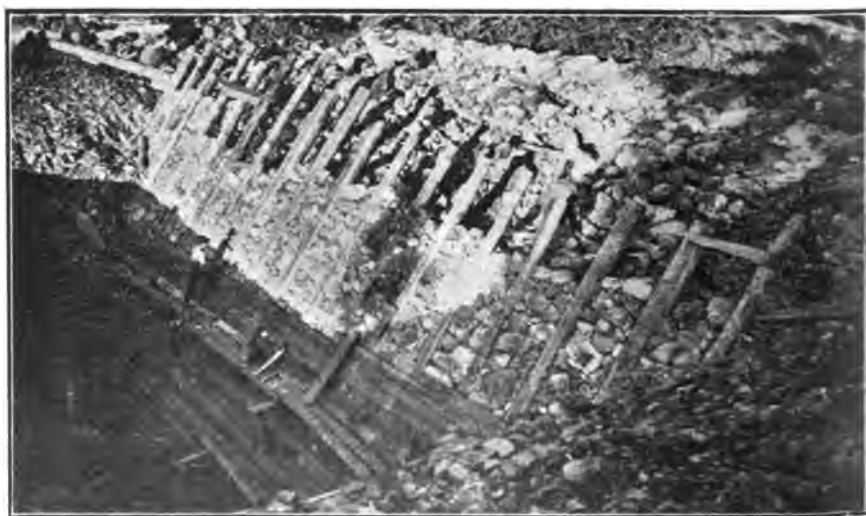
FIG. 345.—THE WEAVER LAKE DAM, CALIFORNIA, SHOWING RECENT CONSTRUCTION.

The Weaver Lake Dam.—A new dam has recently been constructed at Weaver lake, within a mile of Bowman dam, which is typical of the class of rock-fill wood-faced dams. The method of construction is well shown by the photograph, Fig. 345.

Inclined posts, placed at an angle of 45° , are first set up and held in position by struts that are subsequently removed. These posts are long enough to reach from bed-rock to the crest of the dam. The rock-fill is carefully laid by hand between the posts, forming a face flush with the exterior face of the posts. They are spaced 4 feet apart, center to center. At intervals of 6 feet, from bottom to top, an iron rod, $\frac{1}{4}$ of an inch in diameter, passes through each of the posts to an anchorage back in the rock-fill. This anchorage is made by winding the rods around the largest stones that are selected for that purpose. These posts are of varying size, but the smallest are 9 inches across at top.

The plank face is made with but one layer of well-seasoned 3"×8" pine plank, laid horizontally, and driven tightly together. The bottom

edge of each plank is cut with a caulking bevel of one-half inch in the thickness of 3 inches, but no caulking is done by hand, reliance being placed upon the sediment and floating organic matter in the water to make the joints tight. The planks are held by two 6-inch spikes at each post.

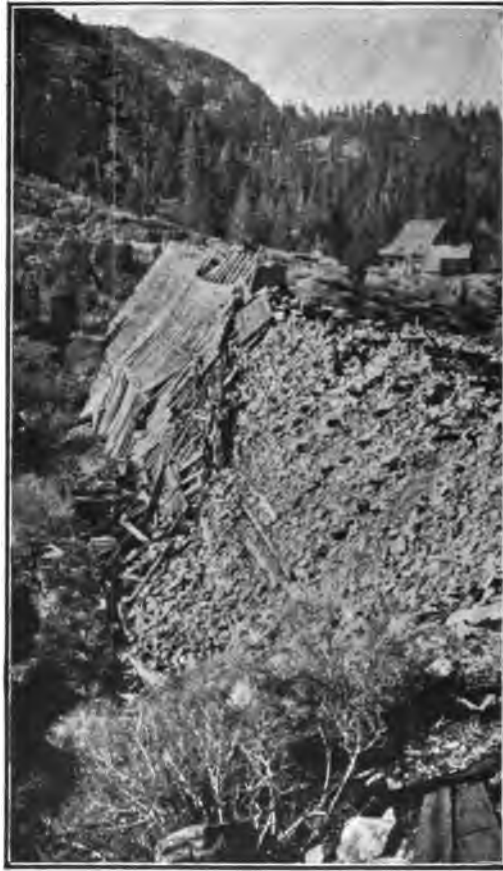
FIG. 346.—UP-STREAM FACE OF ONE OF THE TWO REMAINING ROCK-FILL STRUCTURES WHICH, WITH THE THIRD STRUCTURE DESTROYED IN 1883, ORIGINALLY FORMED THE ENGLISH LAKE DAM.

The English Dam.—On pp. 63–64 the high rock-fill structure known as the English Dam is described, with an account of the bursting and destruction of the main dam, the central one of three which formed the reservoir. Figs. 346, 347, and 348 illustrate the style of construction and present condition of the principal one of the two remaining dams.

The existing dams both have a crest extension of wood, 6 feet high, of similar construction. (See Figs. 346 and 347.) This is also well illustrated by Fig. 348, showing the dry wall laid up on the down-stream face.

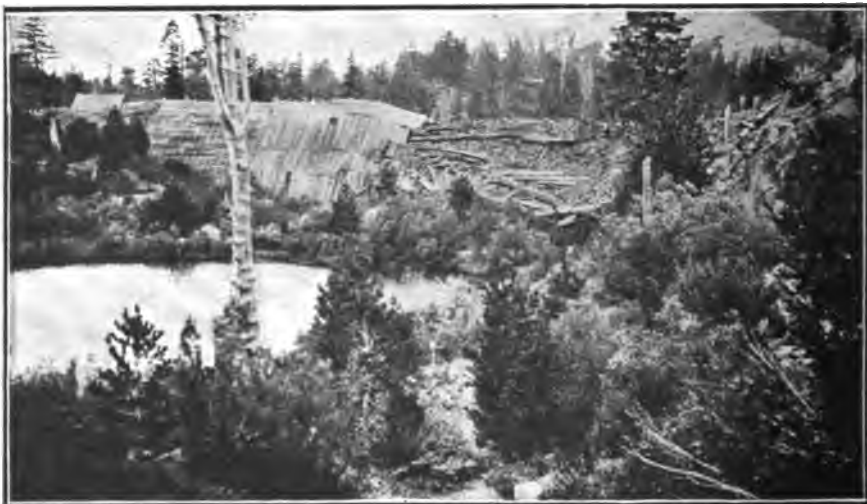
FIG. 347.—GENERAL VIEW OF THE TIMBER SKIN ON UP-STREAM SIDE OF THE ENGLISH LAKE DAM. NOW IN RUIN.

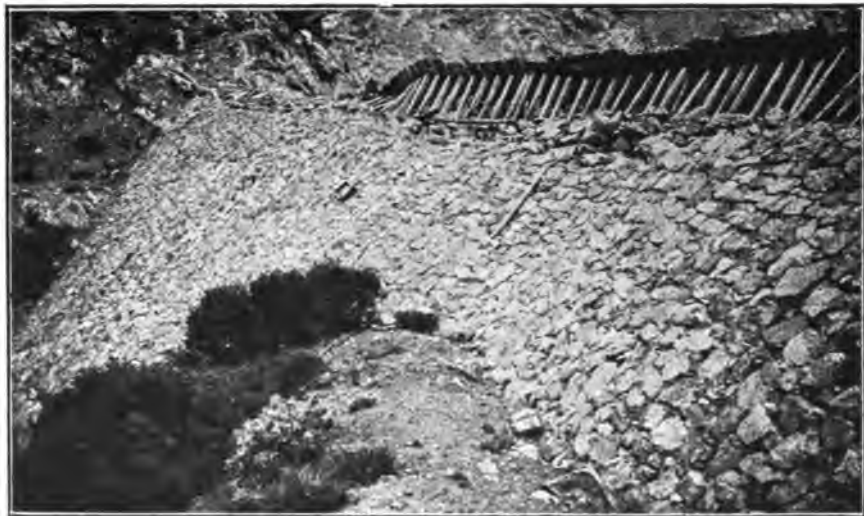
FIG. 348.—THE DOWN-STREAM FACING OF THE ENGLISH LAKE DAM, CONSISTING OF A HAND-LAID DRY WALL IS WELL ILLUSTRATED BY THIS PHOTOGRAPH.

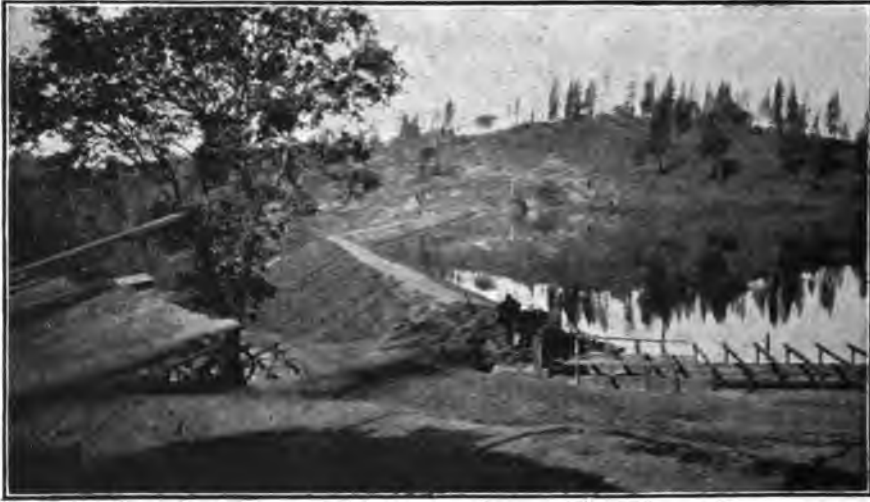
FIG. 349.—THE LAKE FRANCES HYDRAULIC-FILL DAM AS COMPLETED AND IN SERVICE, SHOWING NEW SPILLWAY AND GATES IN FOREGROUND.

The Lake Frances Dam.—All of the photographs accompanying the description of the Lake Frances hydraulic-fill dam on pp. 115 to 125 were taken during construction and before its final completion. Fig. 349, however, is a recent view taken in 1907, showing the finished dam in service. In the foreground is seen a secondary spillway and controlling-gates, added since the dam was completed: This is a wooden flume, 16 feet wide, 6 feet deep below the water-line, the apparent object of which was to allow them to begin wasting water before the lake filled to its full depth at the main spillway level.

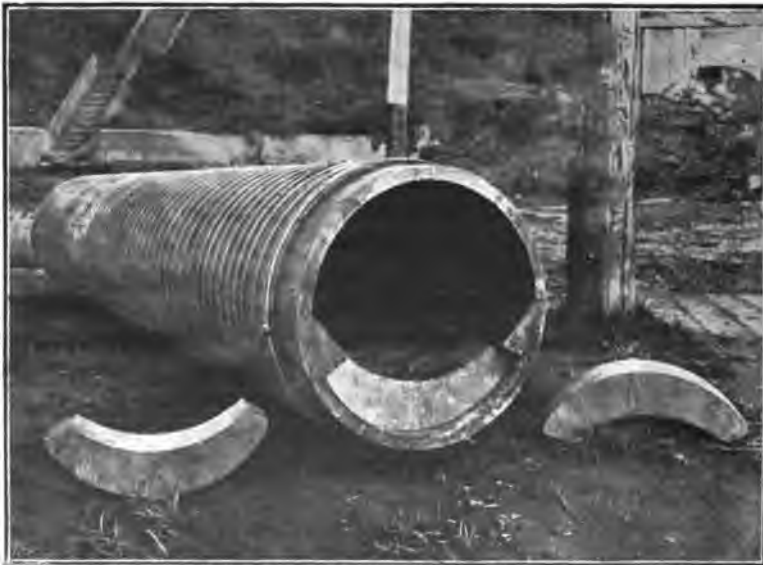
FIG. 350.—THE HOPKIRK WOOD PIPE, FOR CARRYING GRITTY MATERIAL, THE WEAR BEING UPON THE END GRAIN OF THE WOOD.

appliances that have been used on this work, which has been in progress several years, and the methods that have been evolved have a direct bearing upon the construction of hydraulic-fill dams by the same agency, they are of very positive interest, and the illustrations in Figs. 350, 351, 352, 353, and 354 are most acceptable additions to this book.

hill consisted mostly of sand and gravel, some few feet from the top a difficult bank of hard blue clay was encountered. In spite of this complication from 500 to 2000 cubic yards of earth were sluiced out each twenty-four hours, using from 2,000,000 to 8,000,000 gallons of water. The water was carried from a reservoir situated more than half a mile from the work. The grade was such, however, that it gave 60 to 80 pounds pressure. The spoil was carried by the Hopkirk Patent Pipe. This is a stave wooden pipe with a reinforced bottom which can be renewed when worn out. The reinforced bottom is made of fir with the end grain of the wood faced so as to withstand the wear of the spoil.

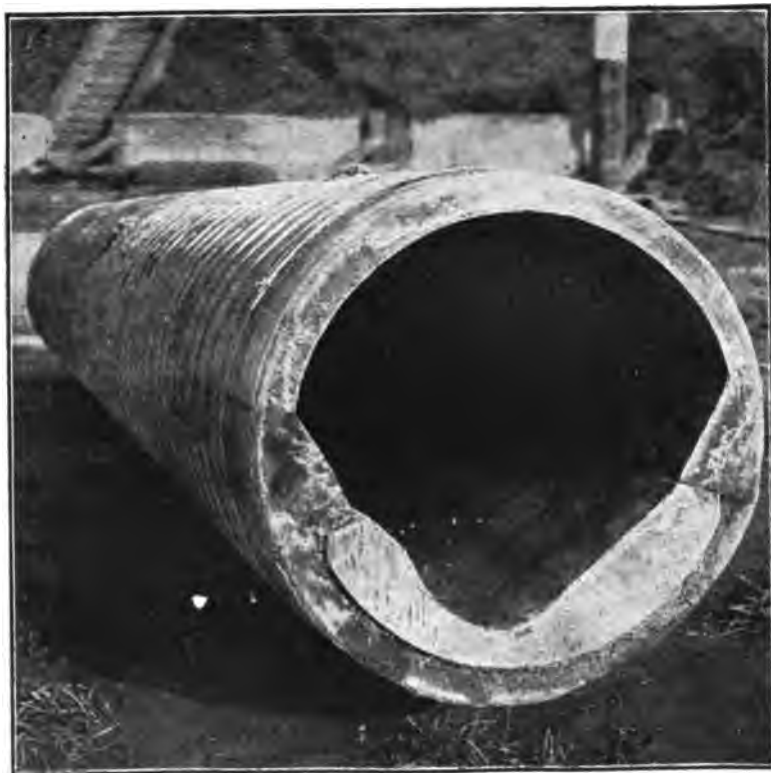
FIG. 351.—THE HOPKIRK PIPE, AFTER SIX AND ONE HALF MONTHS WEAR ON 20% GRADE, IN SEATTLE.

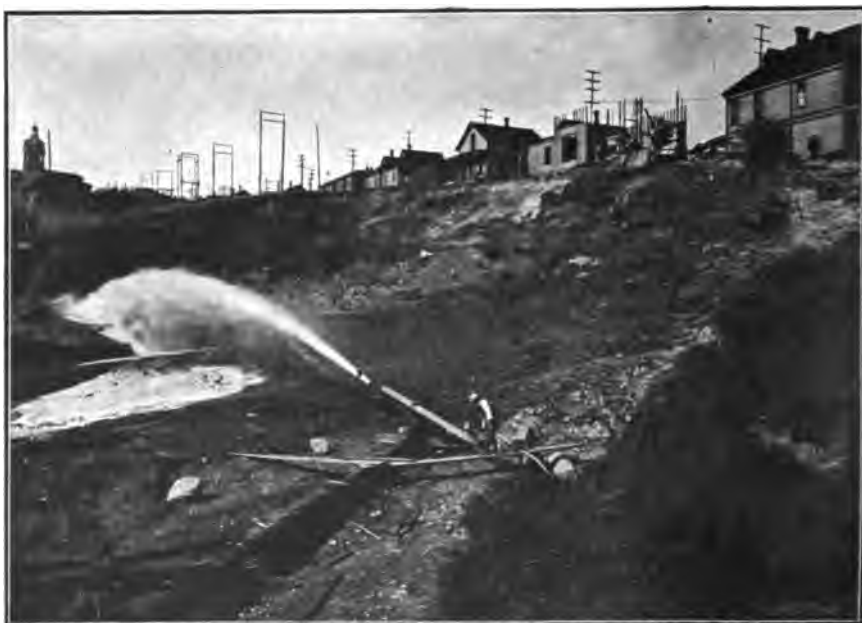
FIG. 352.—THE REGRADING OF JACKSON STREET, SEATTLE, LOOKING NORTH ON MAYNARD STREET. THE HOUSES ARE REMOVED JUST BEFORE THEY ARE UNDERMINED.

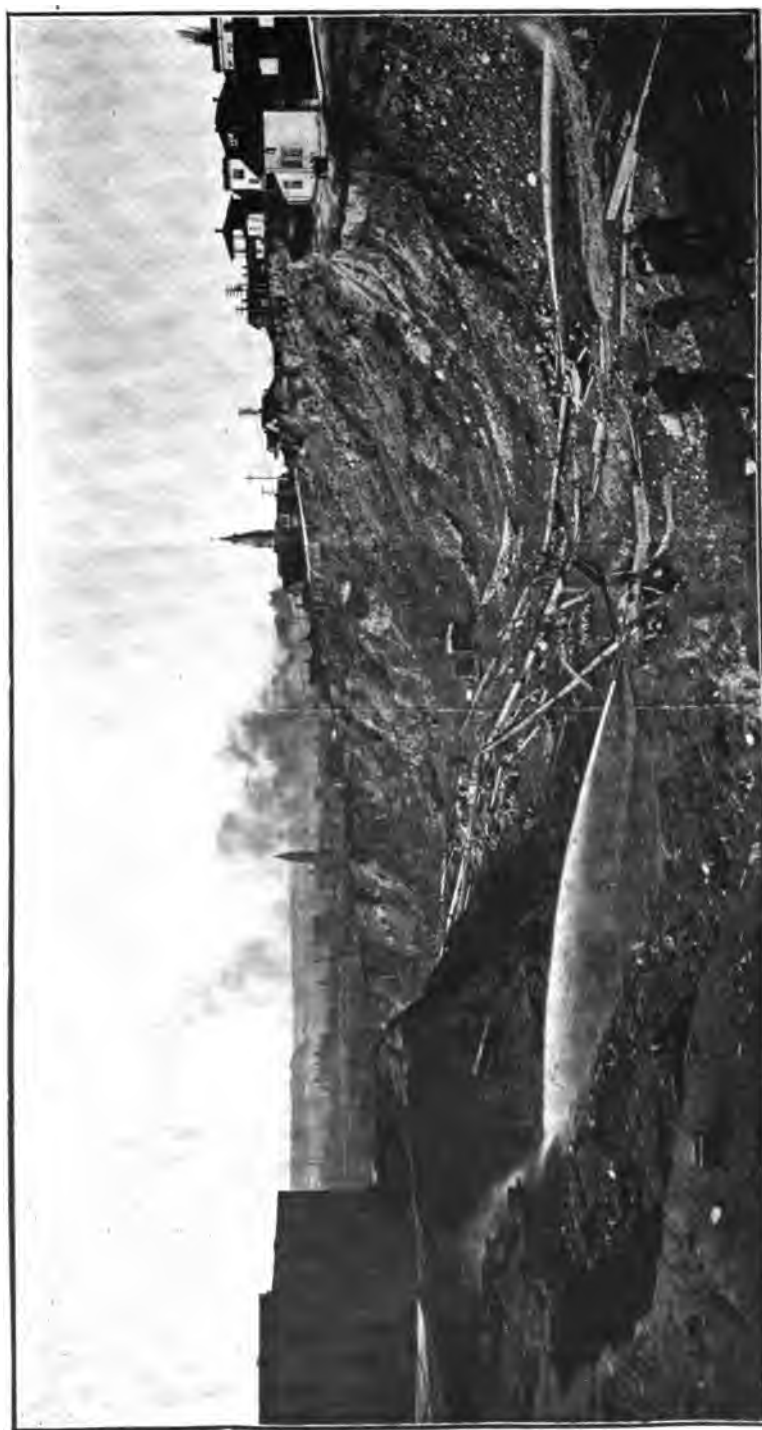
FIG. 353.—THE JACKSON STREET REGRADE BY HYDRAULIC SLUICING, WITH WATER PUMPED.

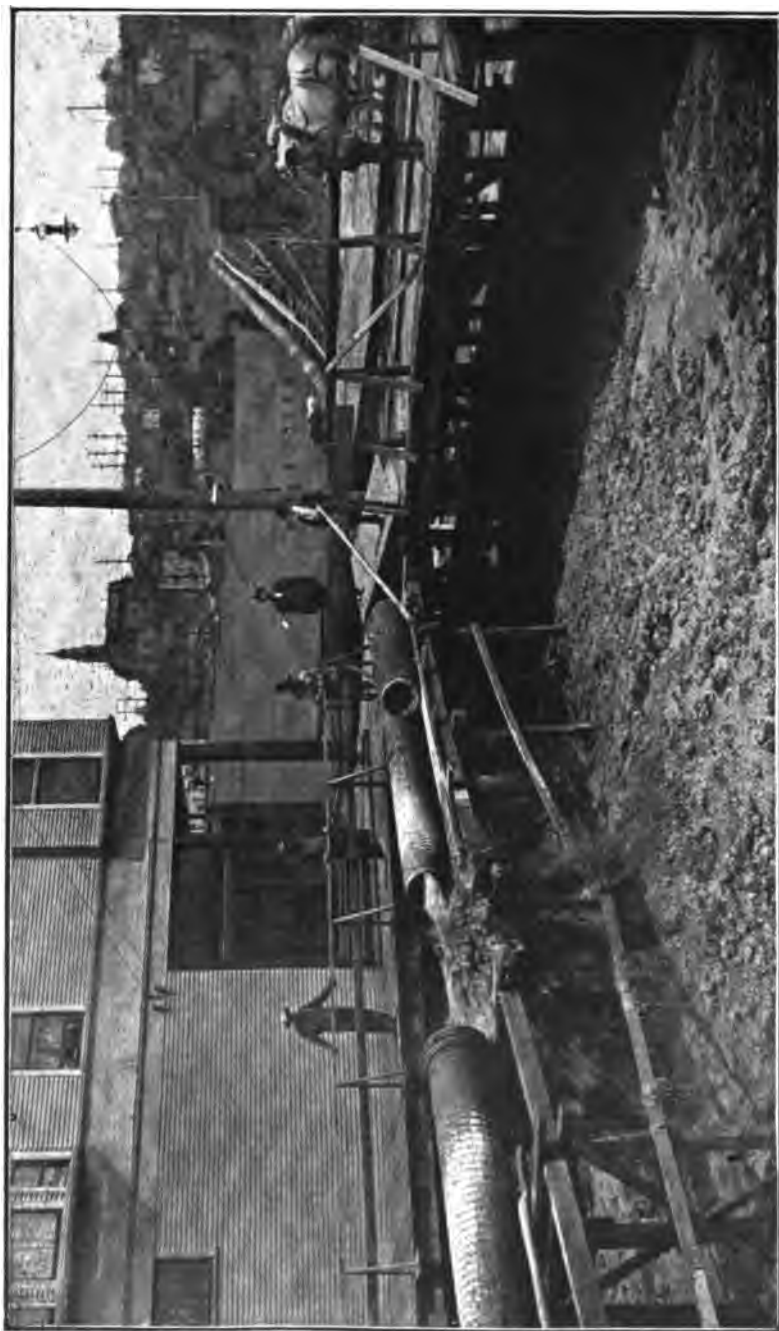
FIG. 354.—THE DELIVERY OF SLUICED MATERIAL TO FILL LOW GROUND IN THE REGRADING OF SEATTLE, WASH. 515

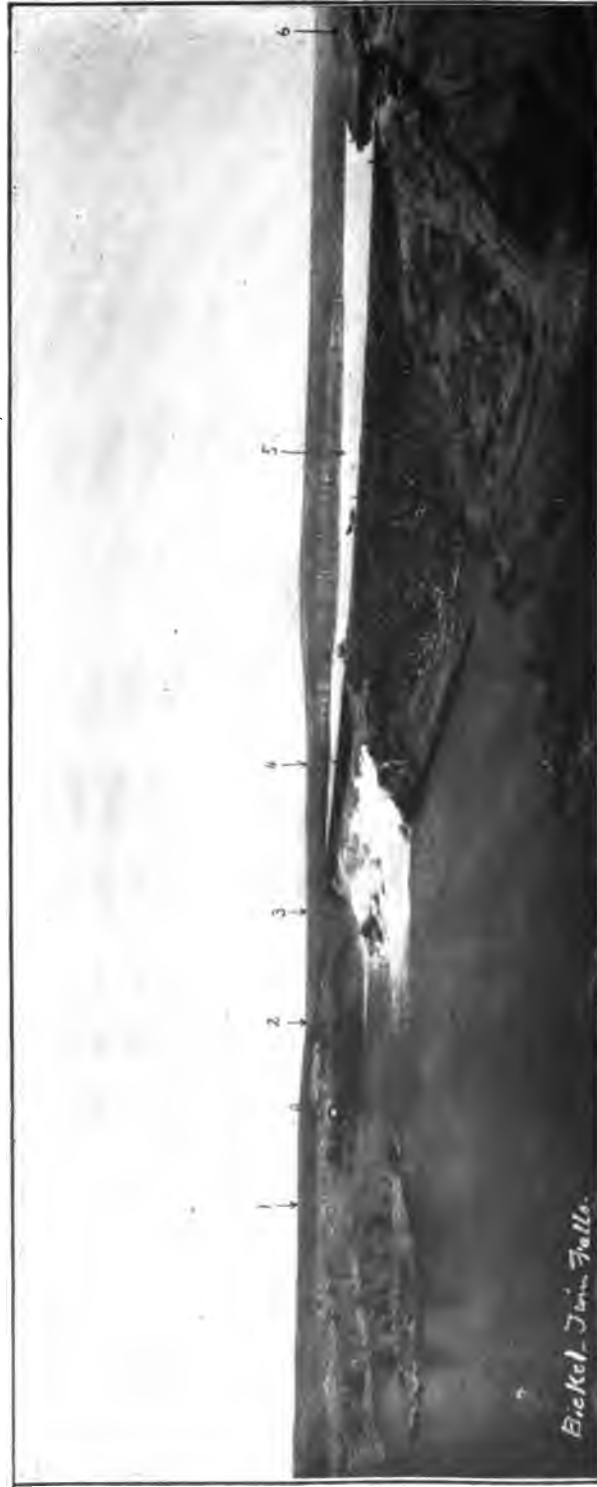
FIG. 355.—THE MILNER DAM, SNAKE RIVER, IDAHO, ON THE TWIN FALLS CANAL PROJECT.

Arrows: 1 indicates the main channel dam; 2, the North Island spillway; 3, the middle dam; 4, the South Island regulating-gates; 5, the south dam; 6, the head-gates of Twin Falls Canal.

The Milner Dam, Idaho.—The photograph shown in Fig. 355 gives a more comprehensive picture of the three combination dams described on page 60 than any of the other illustrations accompanying the article (see Figs. 47 to 53), and will therefore add to the interest in these important and successful dams.

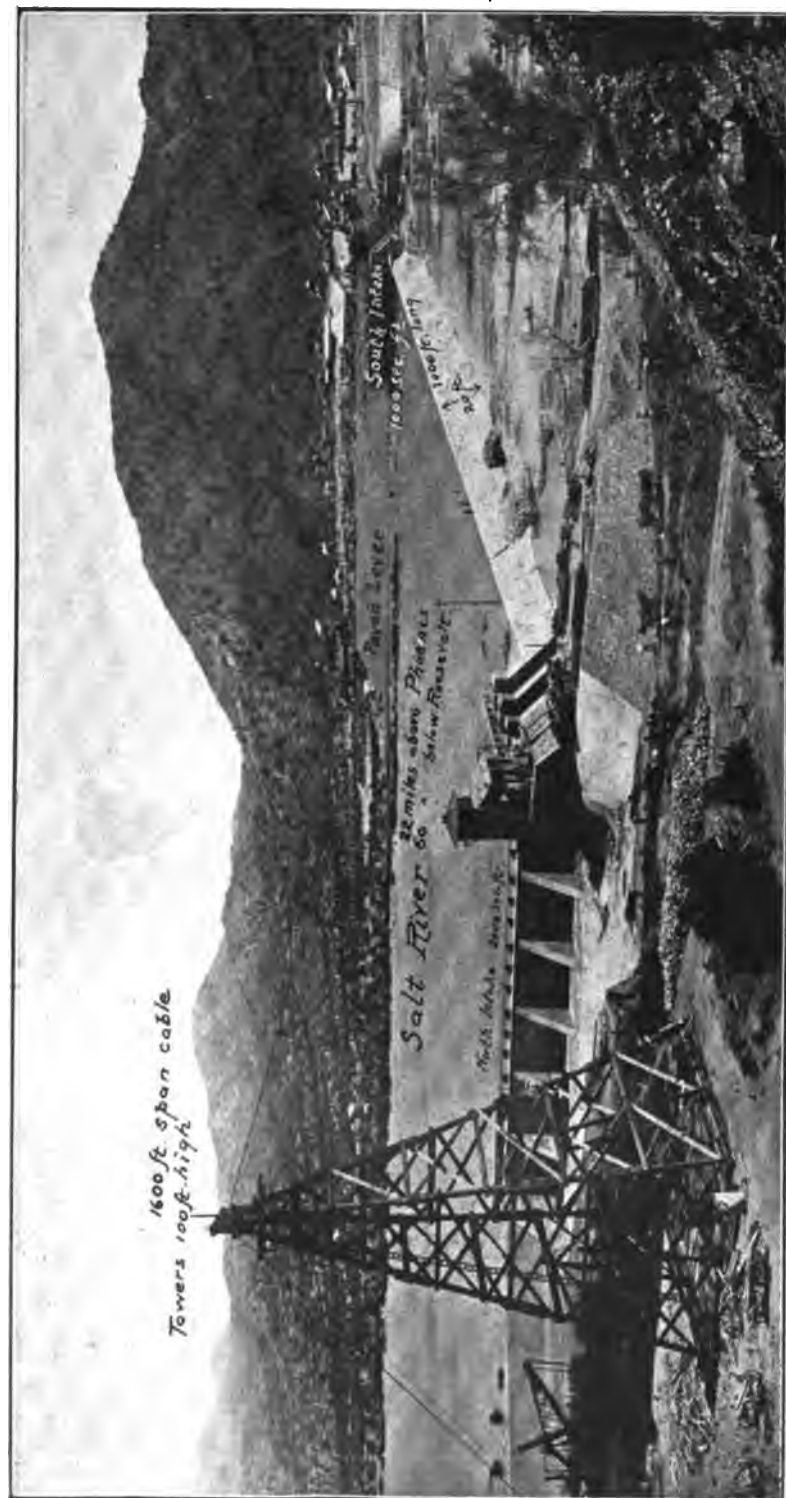
FIG. 357.—THE GRANITE REEF DAM, SALT RIVER, ARIZONA.

The picture, kindly supplied by James Wm. Martin, C. E., engineer in charge of construction, under Lewis C. Hill, Supervising Engineer, Fig. 357, shows clearly the arrangement of the intake gates and canal headworks on either side of the river. Sluiceways have been provided through the dam at each end for the purpose of washing out accumulated sand and maintaining a channel in front of the canal headgates.

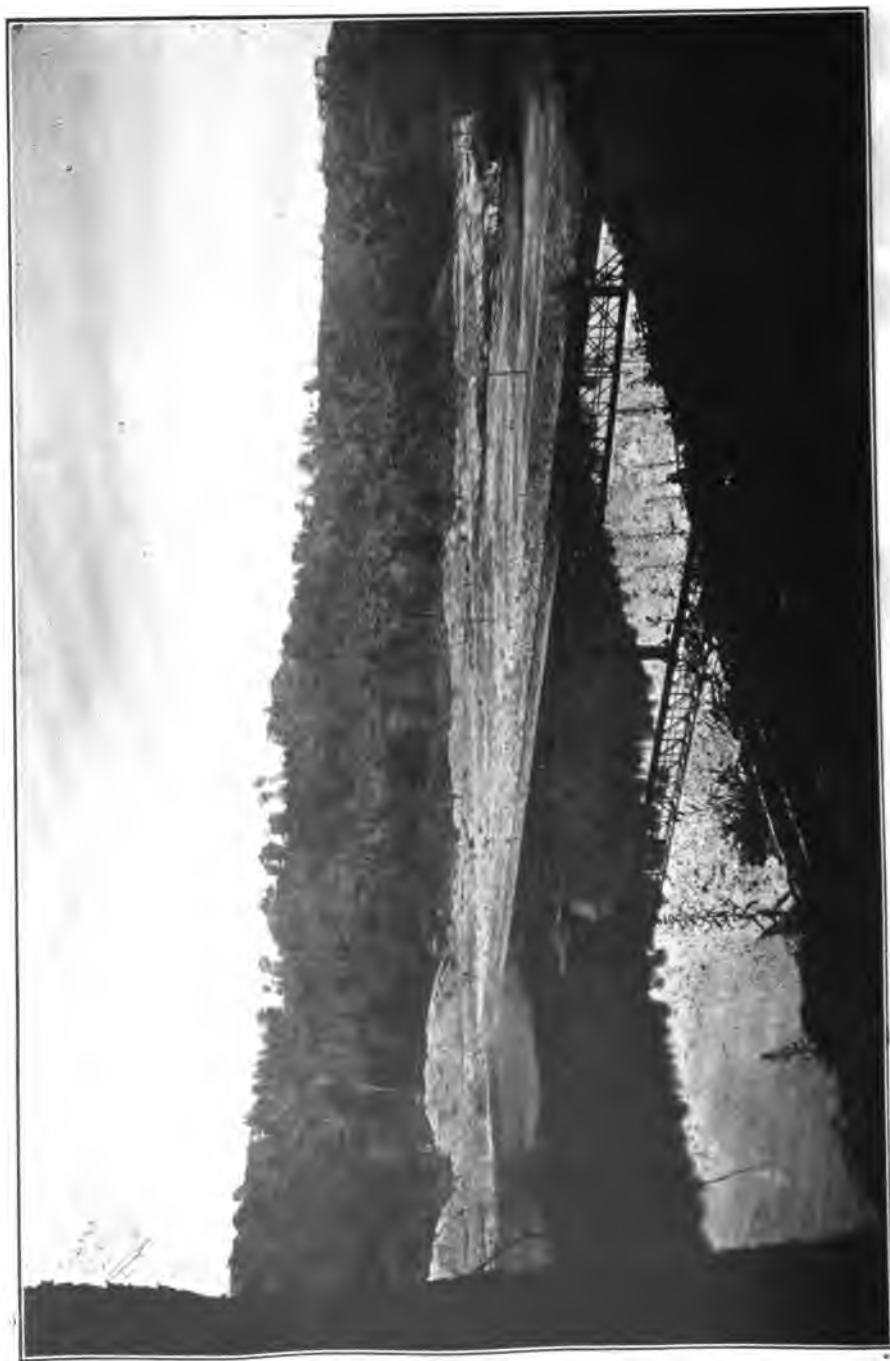
FIG. 358.—THE HINCSTON RUN DAM, CAMBRIA STEEL WORKS, JOHNSTOWN, PA. 520

The Hinckston Run Dam, Pennsylvania.—This dam, located three miles east of Johnstown, Penn., on Hinckston Run, was built in 1904 as a part of the water-supply of the Cambria Steel Company.

It is essentially an earth embankment with concrete core-wall extending from bed-rock up to about one-third the height, or 45 feet below the water-line. The unique feature of the dam is the heavy reinforcement given to it by a backing of cinders, the waste product of the blast-furnaces of the Cambria Steel Works. This cinder-fill is to eventually give the dam a minimum crest width of 500 feet. It is now 300 feet wide at the minimum, and 1000 feet at the widest place. The illustration, Fig. 360, gives a clear idea of the plan of construction. The dimensions are as follows:
